**FEDERAL ON-SCENE COORDINATOR'S
REPORT
for
ALIQUIPPA TIN MILL SITE
ALIQUIPPA, BEAVER COUNTY, PENNSYLVANIA
May 27, 2017 to June 30, 2020**

UNITED STATES
ENVIRONMENTAL PROTECTION AGENCY
REGION III
WHEELING, WEST VIRGINIA

**Federal On-Scene Coordinator's Report
Aliquippa Tin Mill Site**

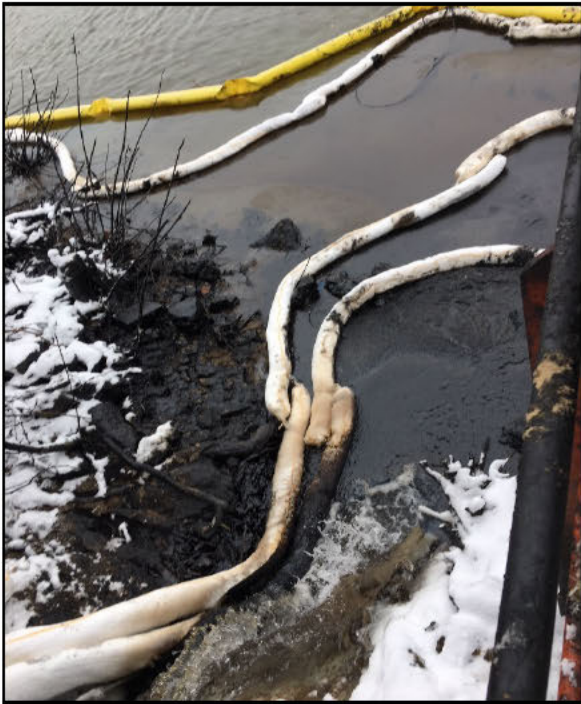
Photolog 13: Transfer of defensive actions to EPA. Conditions on January 31, 2018 (EPA photo: IMG_0030.jpg)

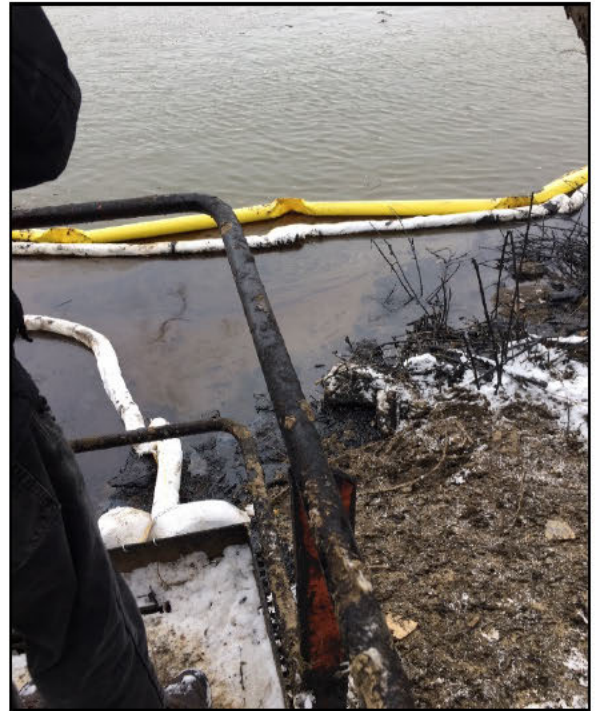
Photolog 14: Transfer of defensive actions to EPA. Conditions on January 31, 2018 (EPA Photo: IMG_0031.jpg)

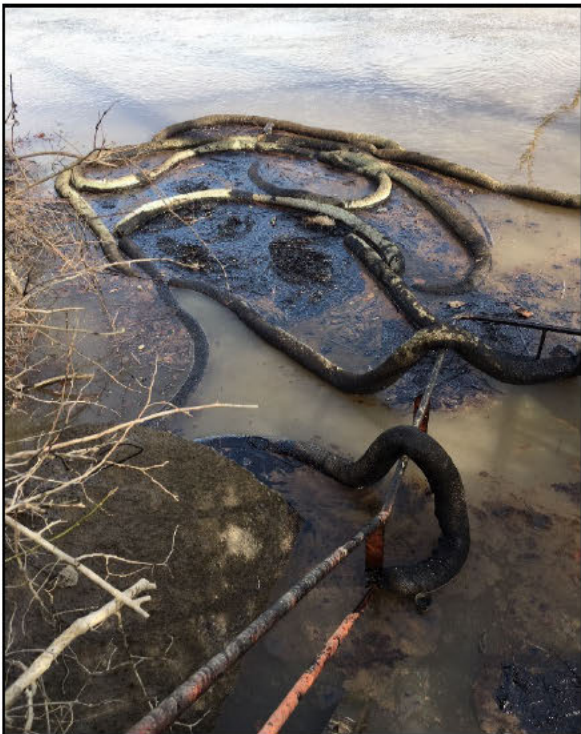
Photolog 15: High water event – booming conditions. February 20, 2018 (EPA photo: IMG_0042.jpg)

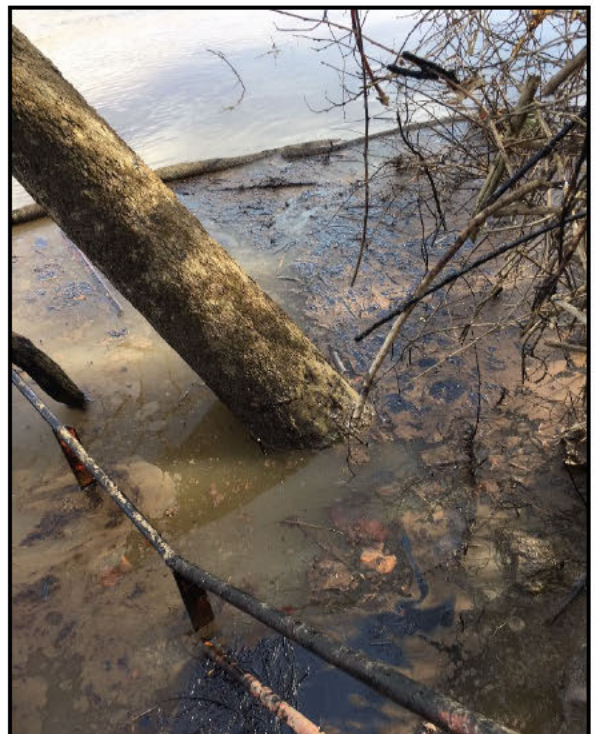
Photolog 16: High water event - booming conditions. February 20, 2018 (EPA photo: IMG_0043.jpg)

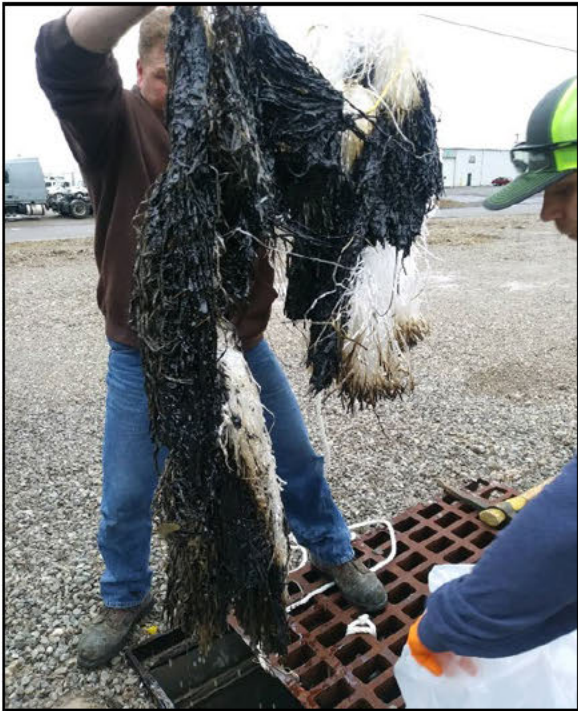
Photolog 17: Condition of oil collection pom-poms on February 22, 2018. (ERRS photo: 3358.jpg)

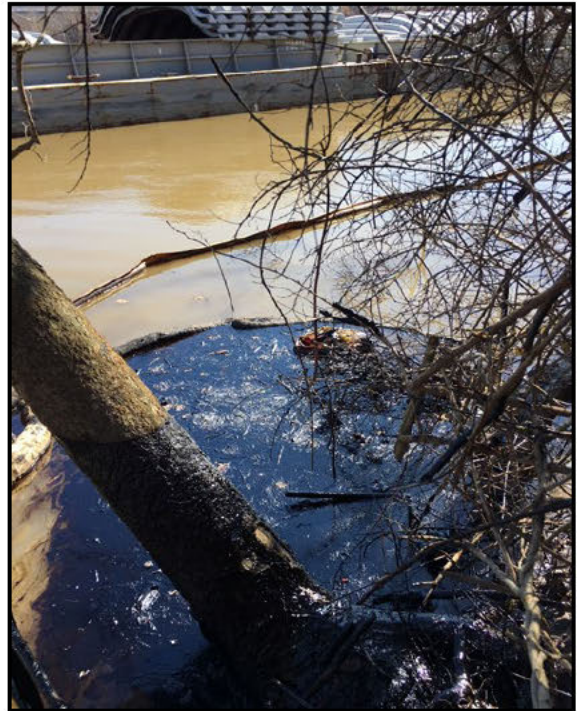
Photolog 18: Outfall conditions on February 27, 2018 (EPA photo: IMG_0052.jpg)

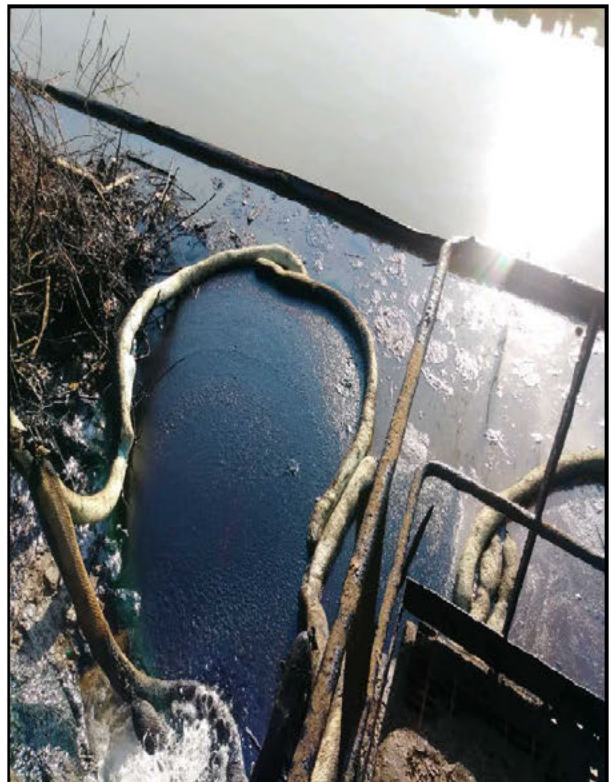
Photolog 20: Outfall conditions on April 10, 2018. (ERRS photo: 3930.jpg)

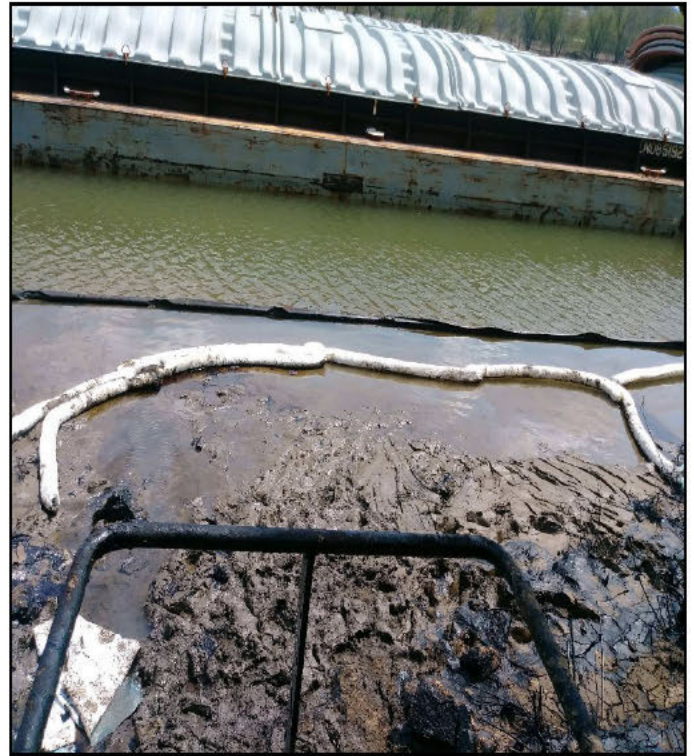
Photolog 22: Outfall and riverbank conditions after cleanup activities and booming changeout - low water conditions. May 3, 2018. (ERRS Photo: 4271.jpg)

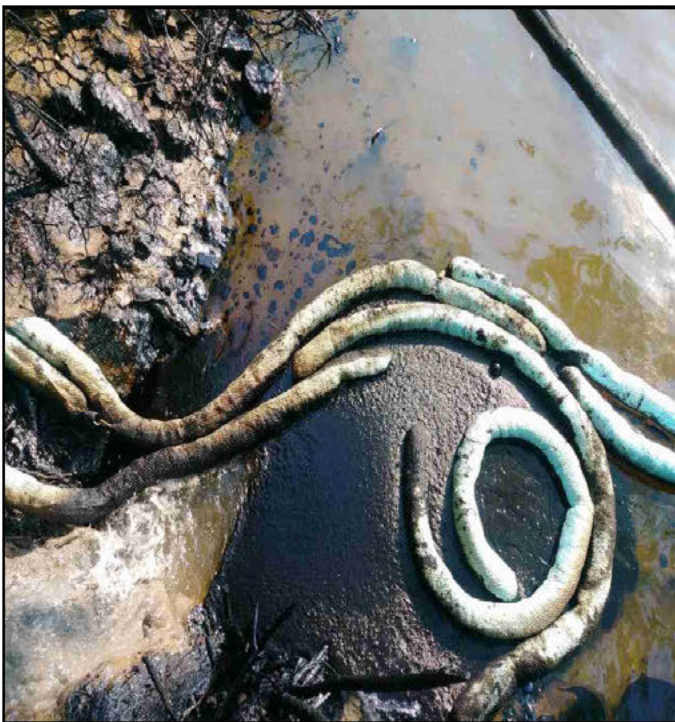
Photolog 23: Outfall conditions on May 29, 2018.
(ERRS photo: 4832.jpg)

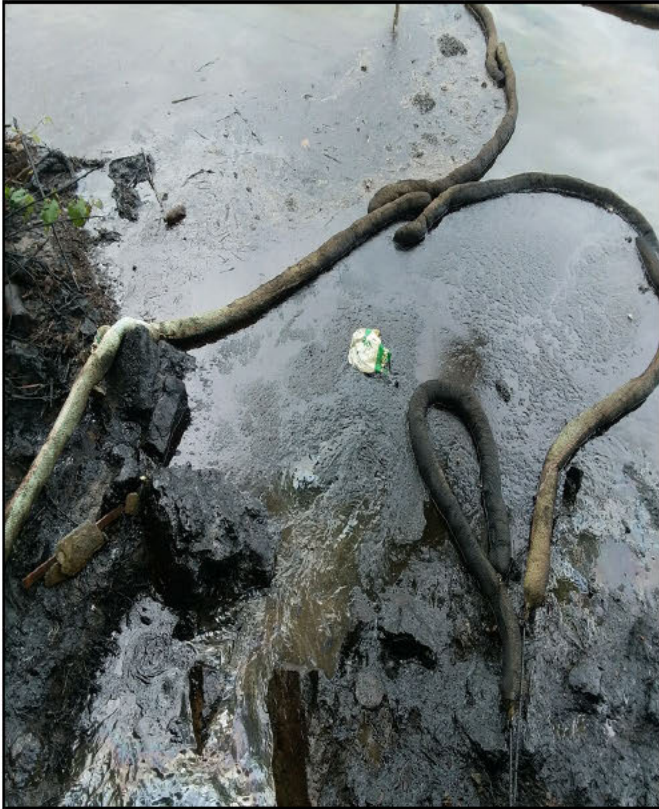
Photolog 29: Outfall conditions on July 9, 2018. (ERRS photo: imagejpeg_4.jpg)

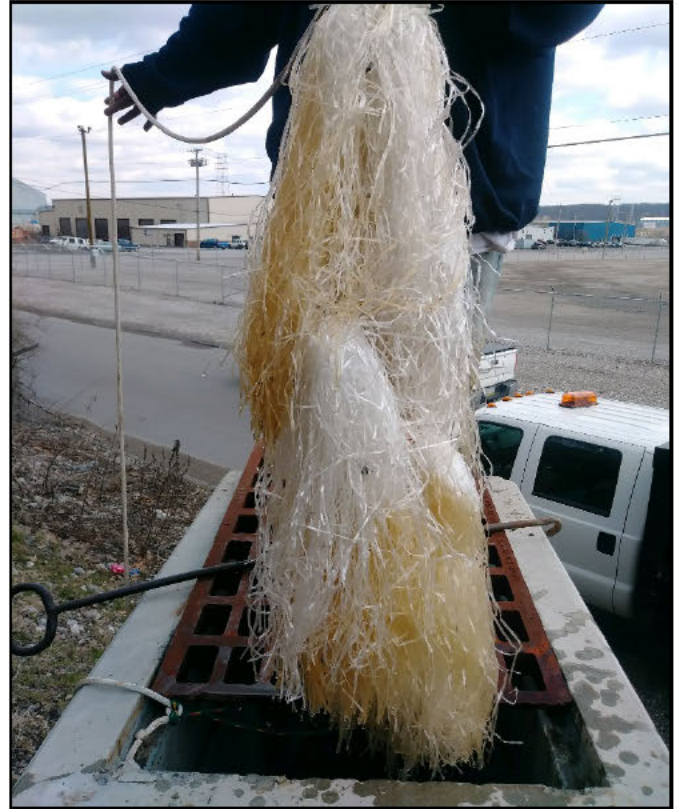
Photolog 30: Condition of oil pom pom placed at Inlet #14 on April 10, 2018. Discoloration is not from oil. (ERRS photo: 3925.jpg)

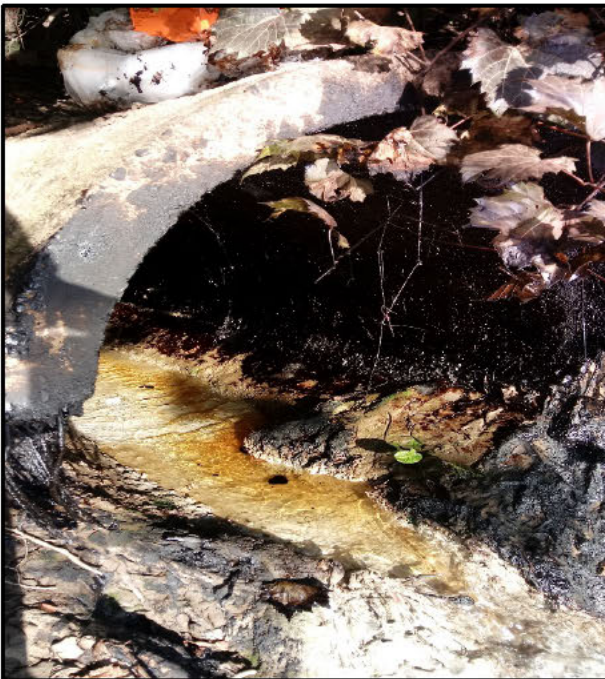
Photolog 33: Conditions of outfall at the beginning of response actions on 10/10/18. (START 1010180900a)

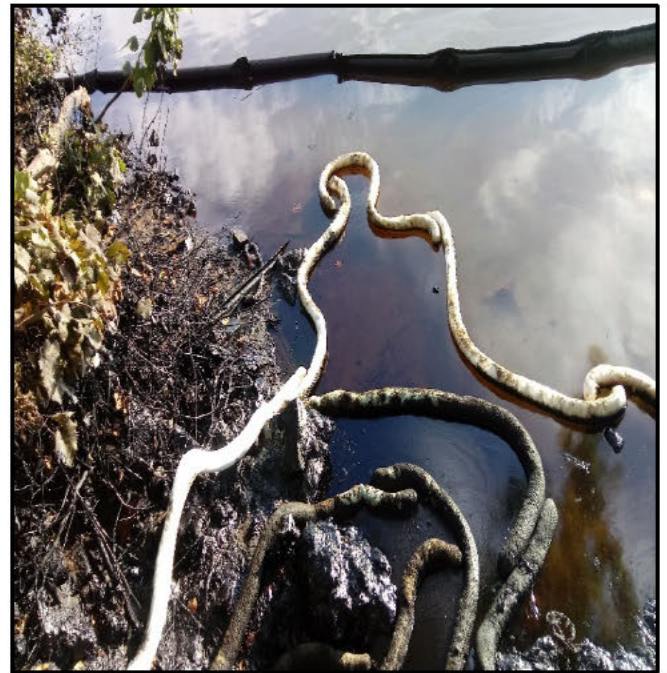
Photolog 34: Conditions at the outfall at the beginning of response actions on 10/10/18. (START photo 1010180900b)

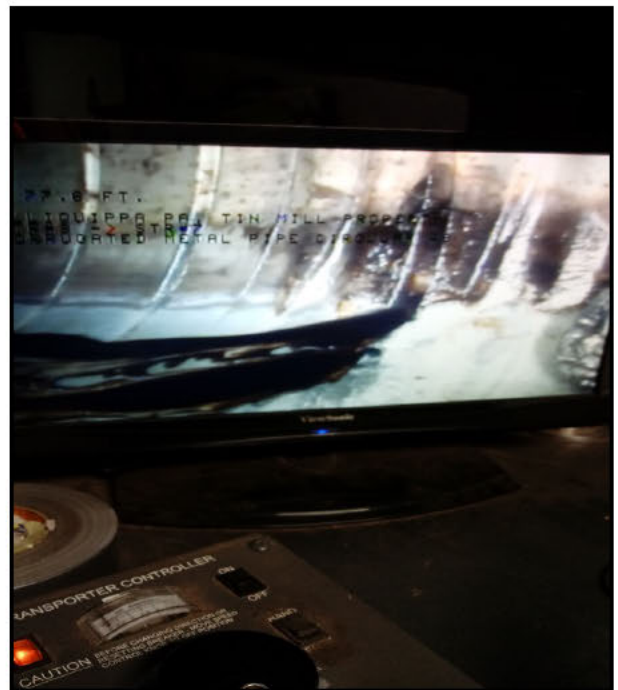
PADEP has confirmed that the source of oil is located on the former Aliquippa Tin Mill property. The camera inspection of the storm drain system shows oil infiltrating into the storm water conveyance system between inlet #7 and inlet #8 on the northern end of the of the property. Since the property has been razed and graded, it is believed that there is an underground source associated with historic operations at the Site.

Photolog 38 – Picture of camera survey video showing oil infiltrating storm piping at 77.6 ft from inlet on 10/11/18. (START photo 1011180922.jpg)

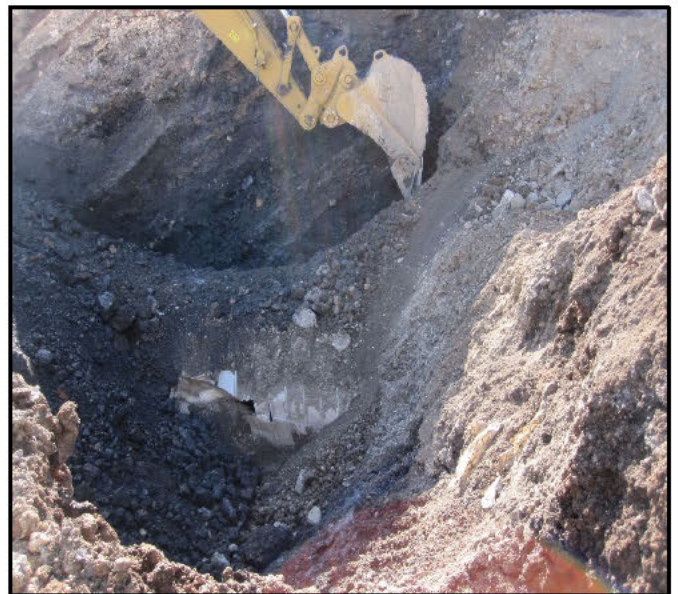
Photolog 46: Excavation around storm water piping. Bucket damaged section while clearing soil. 10/17/18. (START photo IMG_1089.jpg)

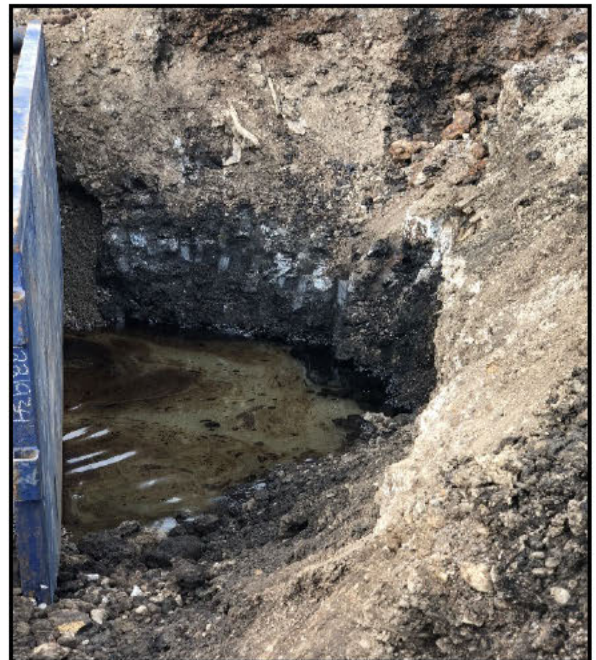
Photolog 50: - Conditions on north side of the stormwater piping once water table was reached. 10/19/18. (START photo IMG_1568.jpg)

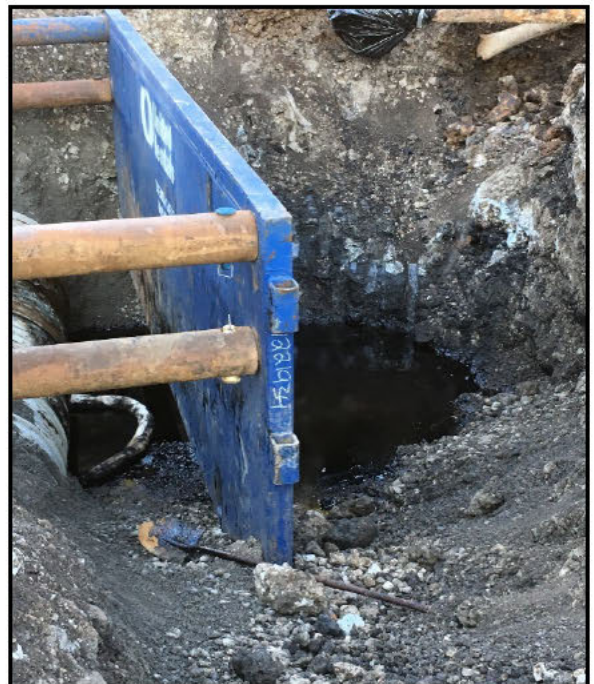
Photolog 58: - Conditions on the north side of the stormwater piping from pocket of oil uncovered during excavation. 10/25/18. (EPA photo IMG_0225.jpg)

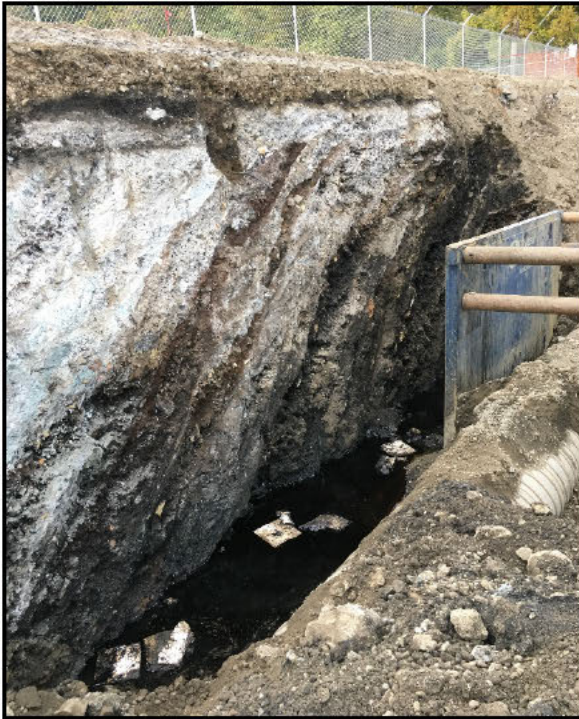
Photolog 59: Conditions on the south side of the storm water piping from oil seeps discovered after excavation. 10/26/18 (EPA photo IMG_0235.jpg)

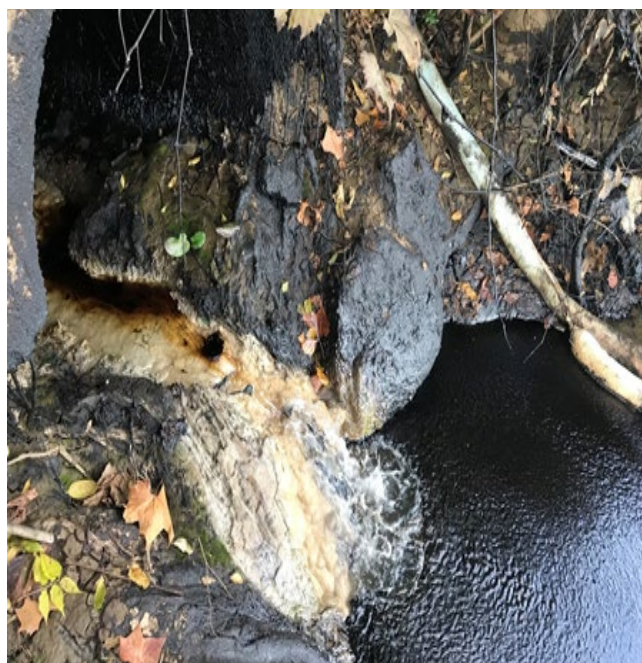
Photolog 66: Conditions at the outfall on 10/30/18. Large amount of oil at the base of outfall. Daily removal of oil (START photo IMG_8817.jpg)

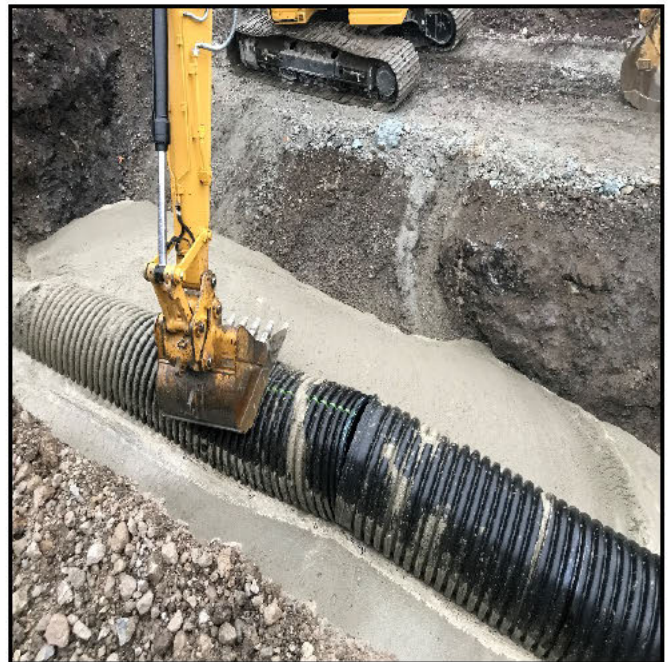
Photolog 70: Flowable fill caused piping to lift and open at joints. 10/31/18 (START photo IMG_8966.jpg)

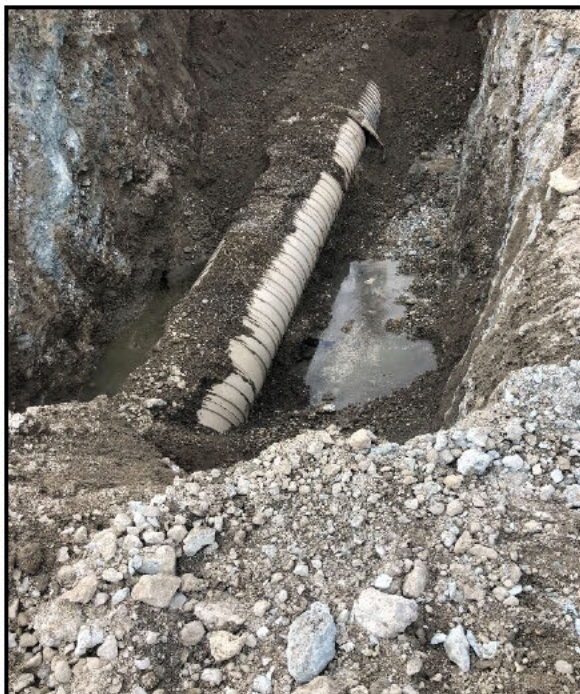
Photolog 81: Begin excavation of the next 2 sections of storm water piping. Less oil observed seeping into groundwater. 11/7/18 - (START photo IMG_1929.jpg)

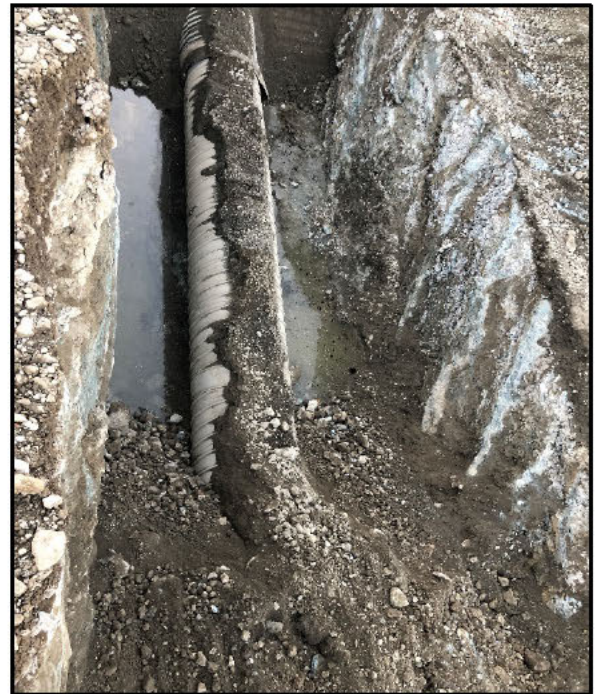
Photolog 82: Begin excavation of the next 2 sections of storm water piping. Less oil observed seeping into groundwater. 11/7/18 (START photo IMG_1934.jpg)

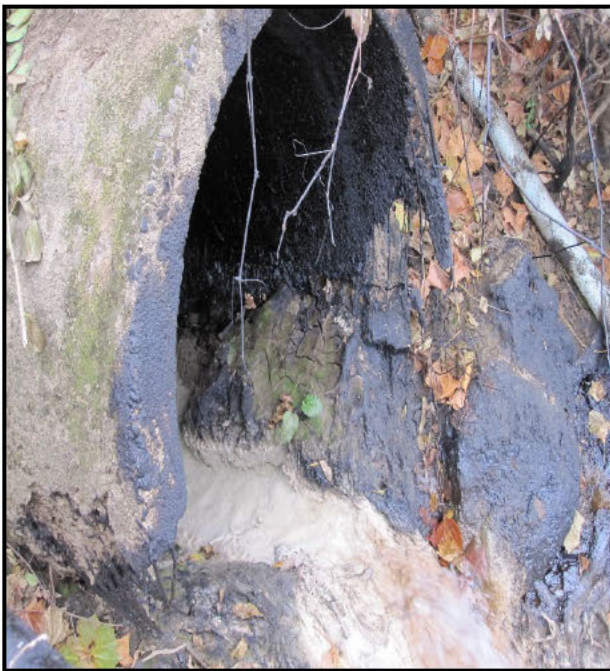
Photolog 85: Conditions at outfall. No visible oil being discharged. 11/14/18. (START photo IMG_1114.jpg)

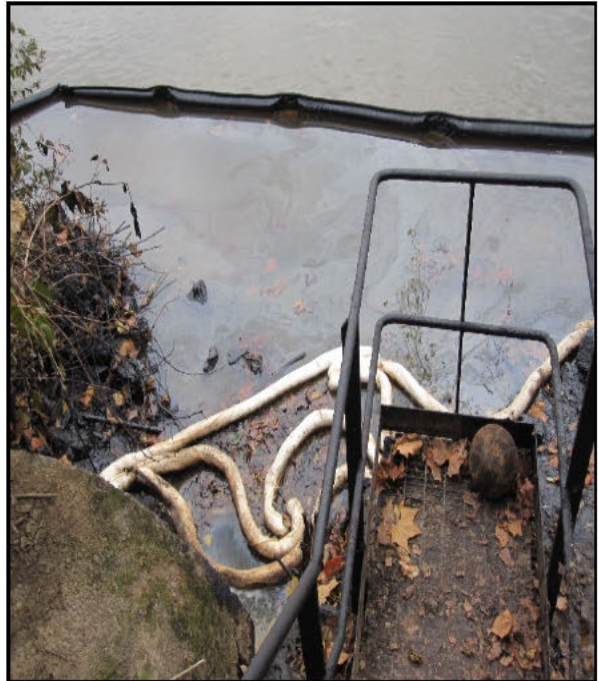
Photolog 86: Conditions at outfall. Sheening observed inside boom. 11/14/18. (START photo IMG_1116.jpg)

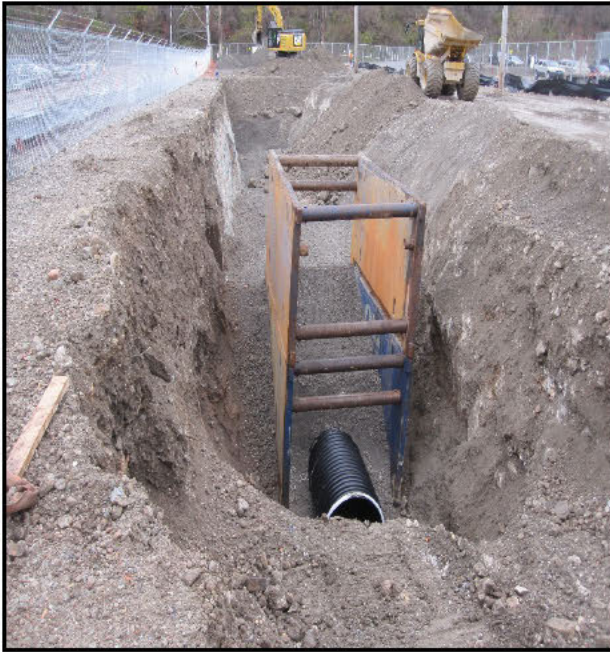
Photolog 91: Begin work on the last 80 feet of replacement piping. Side wall conditions changed. Fill material vs. slag. Need to create step on north side of trenching. 12/3/18. (START photo IMG_11.74.jpg)

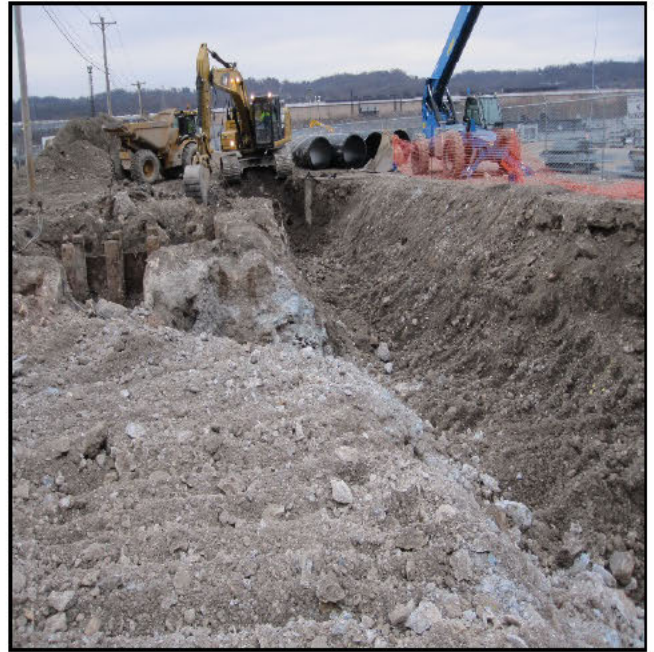
Photolog 92: Building foundation encountered while excavating material to create step down area for excavator. Required a hammer ram to breakdown area. 12/6/18. (START photo IMG_1191.jpg)

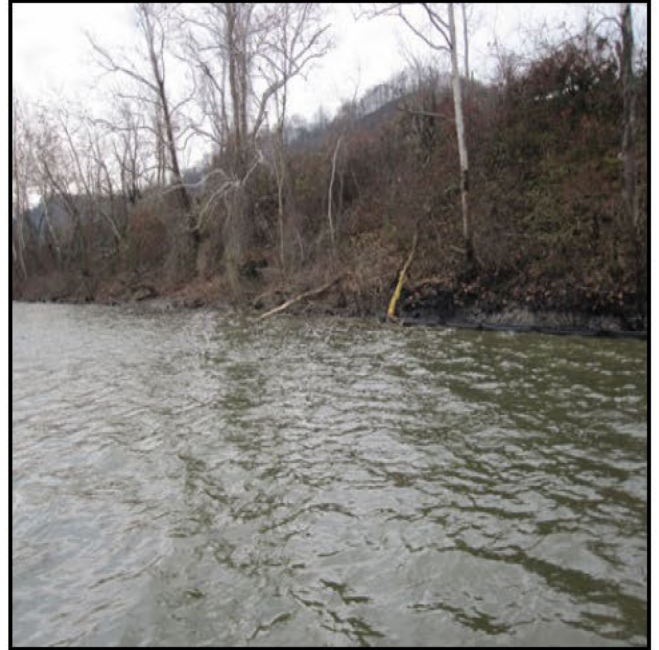
Photolog 96: - Photos taken from river to document riverbank conditions on the southern side of the outfall. Facing west. 12/6/18. (START photo IMG_1200.jpg)

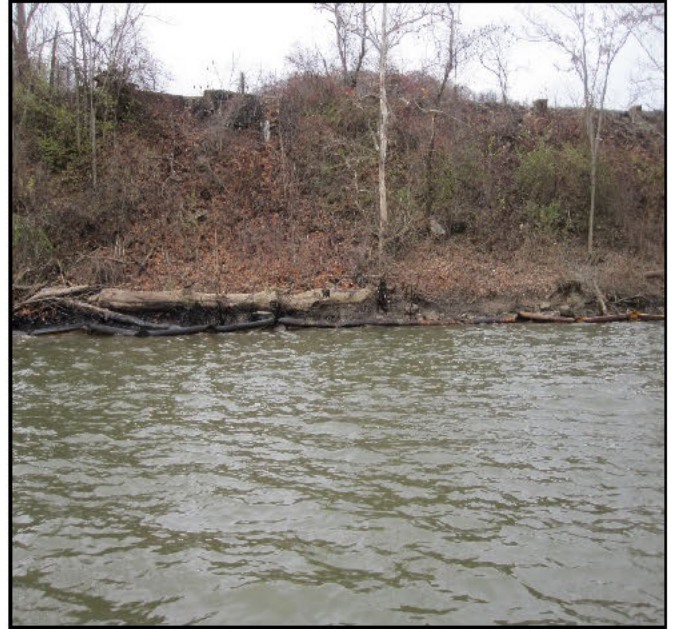
Photolog 98: Photos taken from river to document riverbank conditions on the northern side of the outfall. Facing west. 12/6/18. (START photo IMG_1197.jpg)

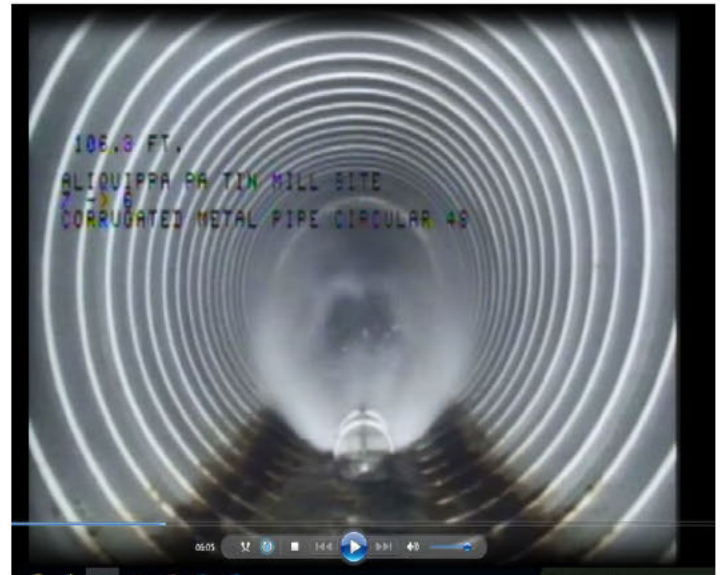
A camera survey conducted inside the entire length of storm water conveyance system in October 2018 did not show oil infiltrating the stormwater system from inlet #7 to the outfall. A few locations showed infiltration of groundwater. A decision was made not to replace the remaining 1300 feet of storm water piping. The camera survey did show dirt and debris at a number of locations within the piping that could retain residual oil and allow a continual release of oil through the storm drain system and into the Ohio River. The camera survey also showed oil staining at different levels within the 48-inch piping based on fluctuating water levels inside the piping as influenced by the river height. A pipe cleaning subcontractor was hired to vacuum out the dirt and debris located between inlet #7 through inlet #2. Once all of the debris was removed, a high-pressure jet washing machine was run through the 48-inch piping in an attempt to remove oil residue that was observed on the inside walls of the piping. The jet washing did not remove all of the oil staining on the inside of the piping since some of the oil had hardened and similar to a tar like consistency. The residual left on the piping is not causing sheening coming from the outfall.

Photolog 106: Photo of storm water piping conditions after cleaning. Photo extracted from camera survey video. 2/3/18

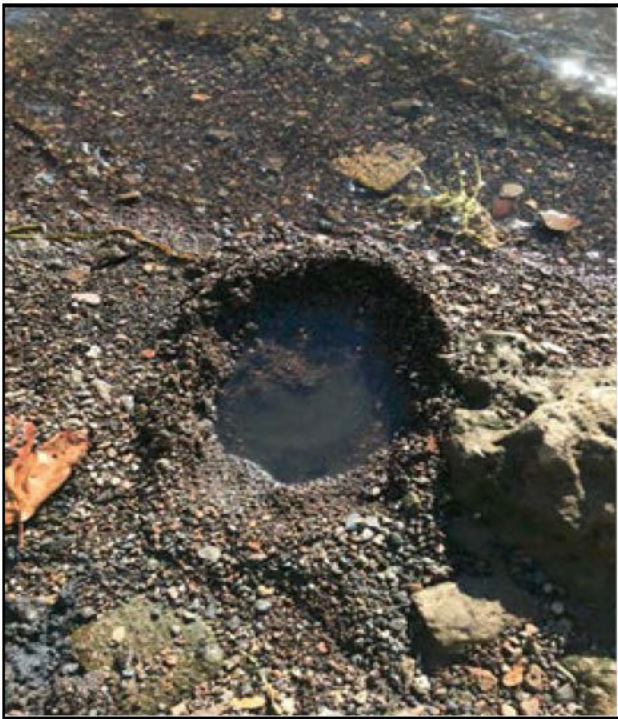
Photolog 109: Facing Down. Small ditch left by footprint, showing water with a silvery sheen of oil. 09/19/19. (START photo IMG_0335)

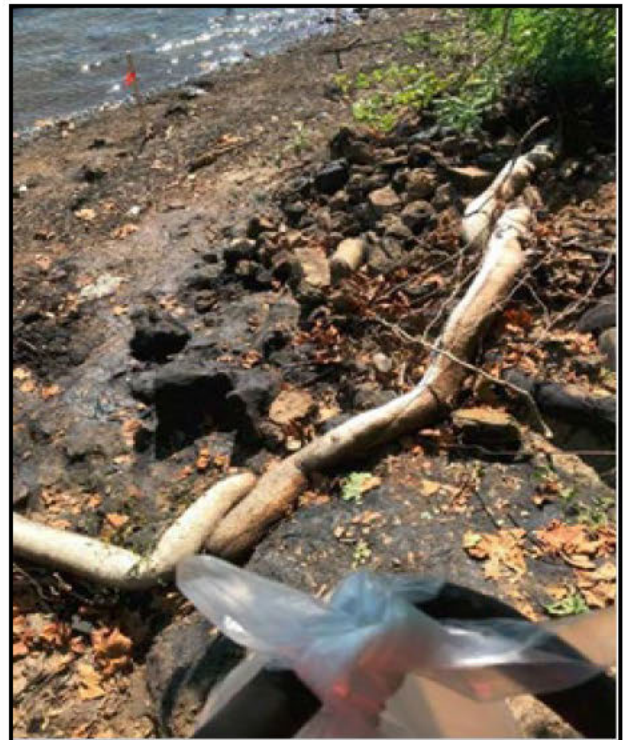
Photolog 110. Facing S/SE. Pile of rocks and material with dark oil staining to be disposed. 09/19/19. (START photo IMG_0339)

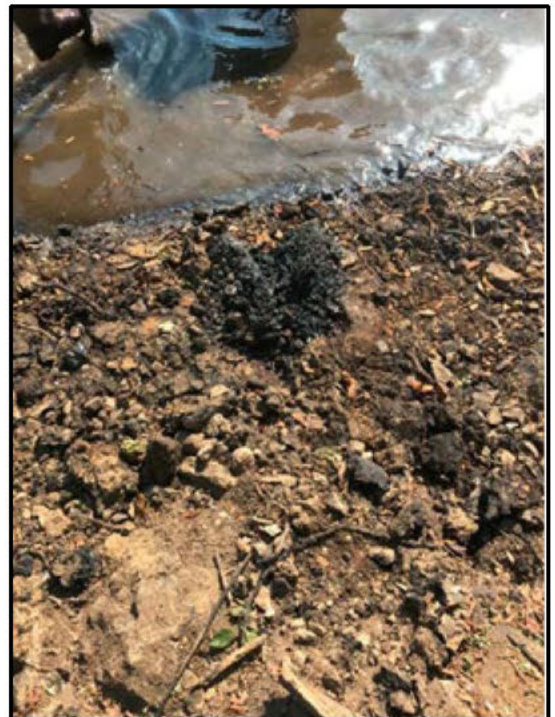
Photolog 118: Facing Down. Oil stained material from 240' - 260' interval. 09/20/19. (START photo IMG_0347)

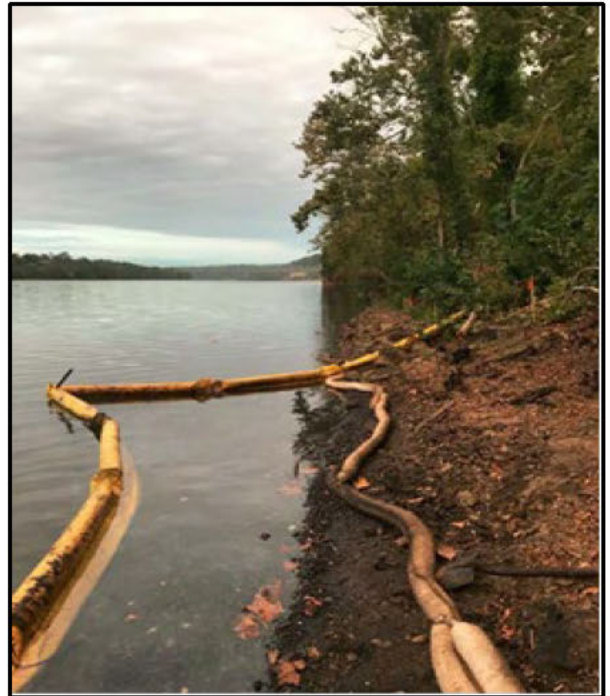
Photolog 120: Facing S. Rainbow sheen observed on surface at 240'-260' after agitation. 09/20/19. (START photo IMG_0964)

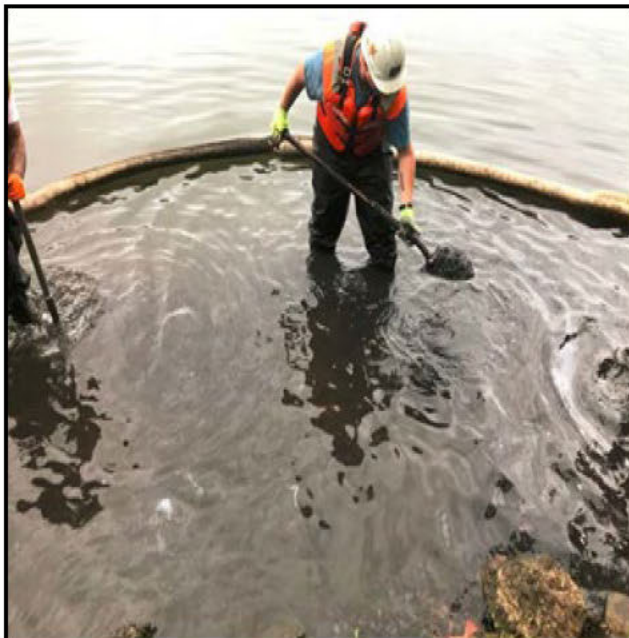
Photolog 121: Facing Down. Agitation releasing oil and rainbow sheen from sediments at 340'-360' interval. 9/23/19. (START photo IMG_0966)

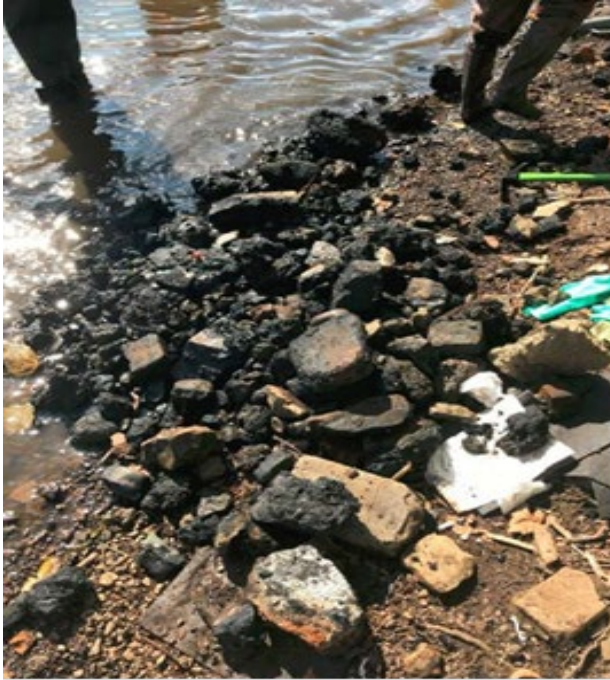
Photolog 123: Facing Down. Oil stained rocks and bricks removed from 320'-340' interval. 9/24/19. (START photo IMG_0992).

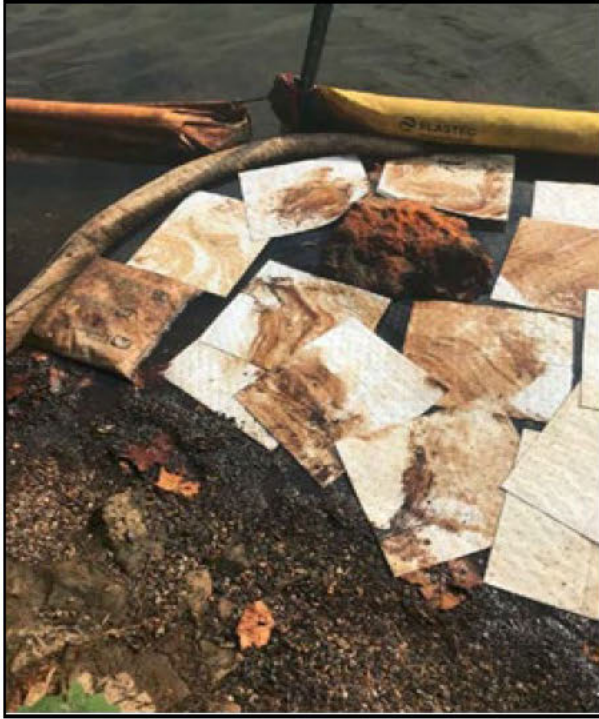
Photolog 138: Facing Down. Additional absorbent pads placed at 110' marker and observed picking up heavier oil. 10/02/19. (START photo IMG_1005)

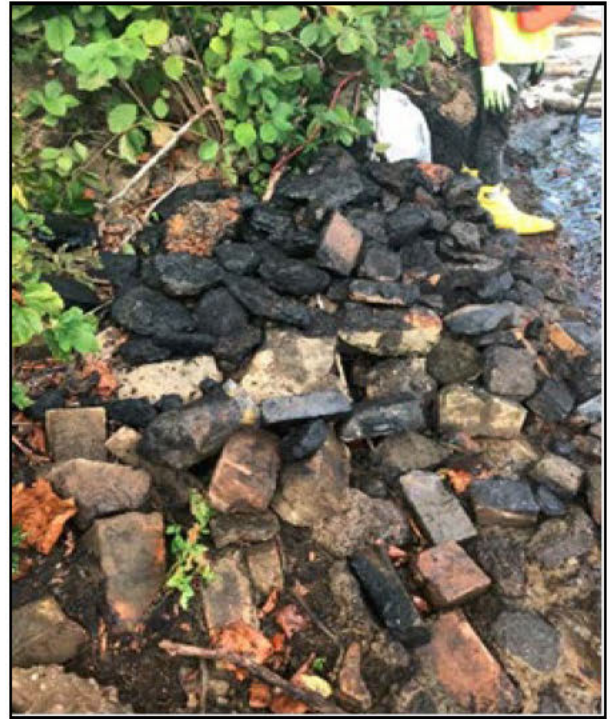
Photolog 139: Facing Down. Oil stained rocks and bricks removed from 30'-60' interval. 10/02/19. (START photo IMG_1007)

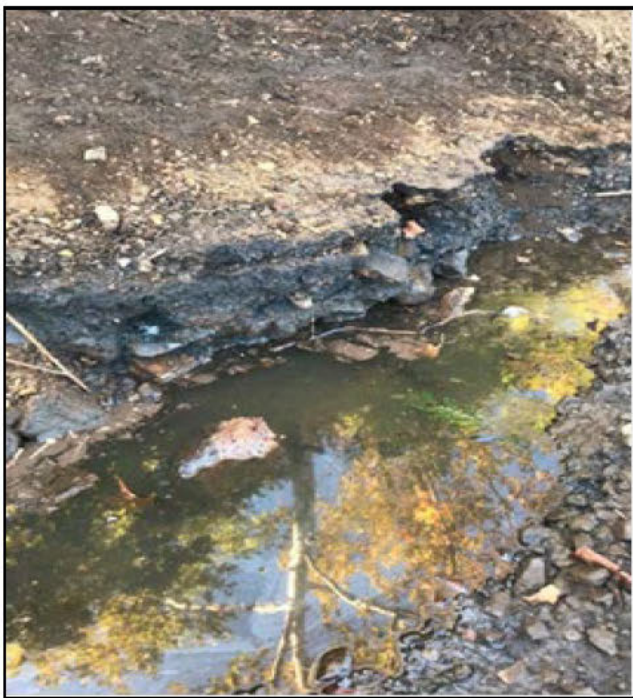
Photolog 148: Facing West. View of area where the riverbank was dug out and removed. Black oil staining visible on surface. 10/10/19. (START photo IMG_0391)

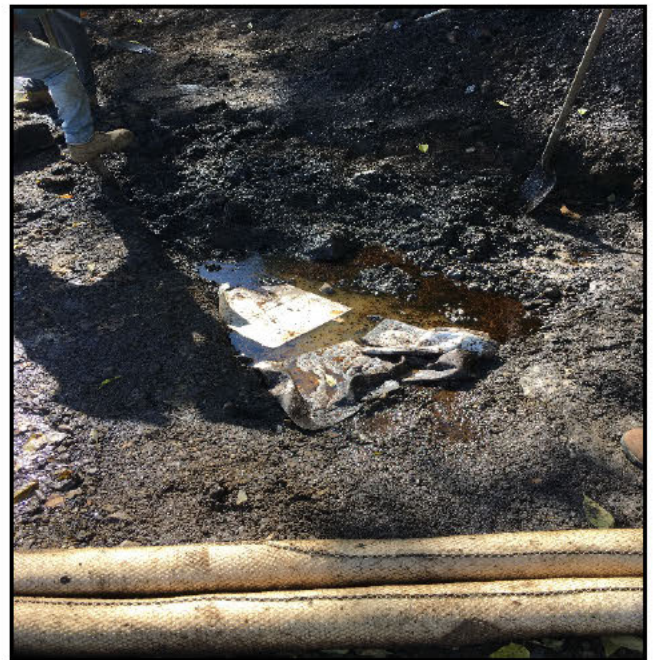
Photolog 157: Cleanup operations in front of the outfall. Oil being removed with the loose gravel. 10/23/19. (EPA photo IMG_0640)

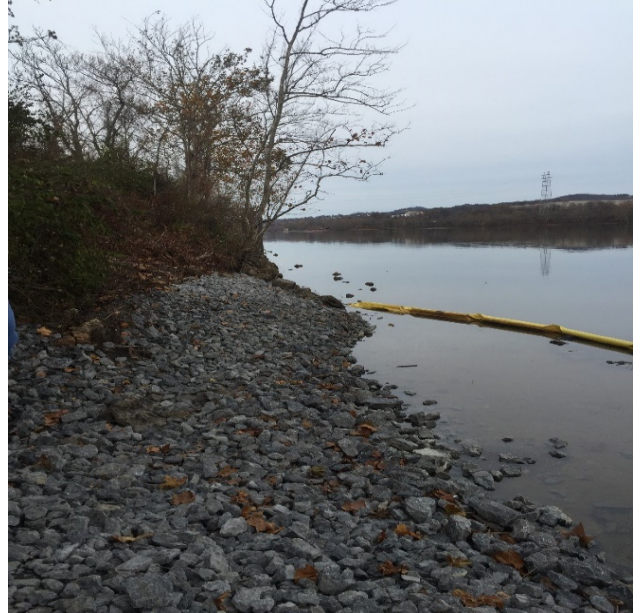
Photolog 163: Looking north from the outfall. Final site conditions. 100 ft of containment boom to remain until June 30, 2020. 11/13/19. (EPA photo IMG_0480.jpg)

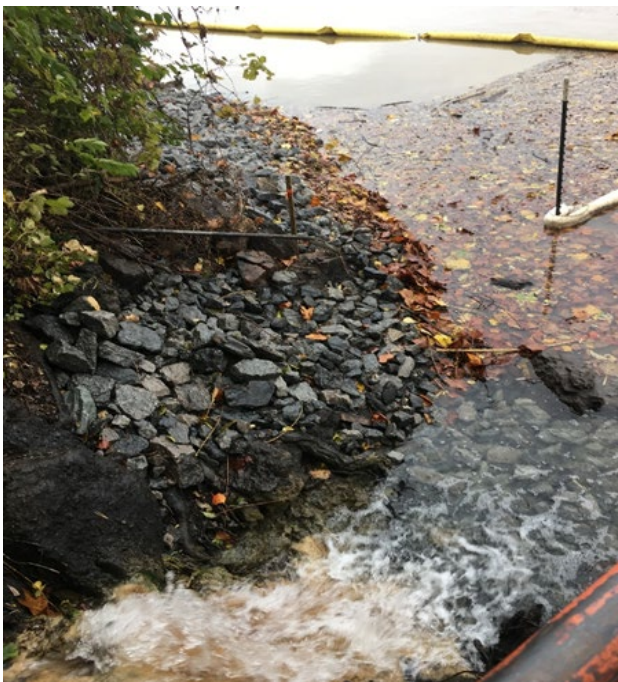
Photolog 164: Site conditions of outfall. No oil or sheen coming from the outfall. 11/1/19. (EPA photo IMG_0659.jpg)

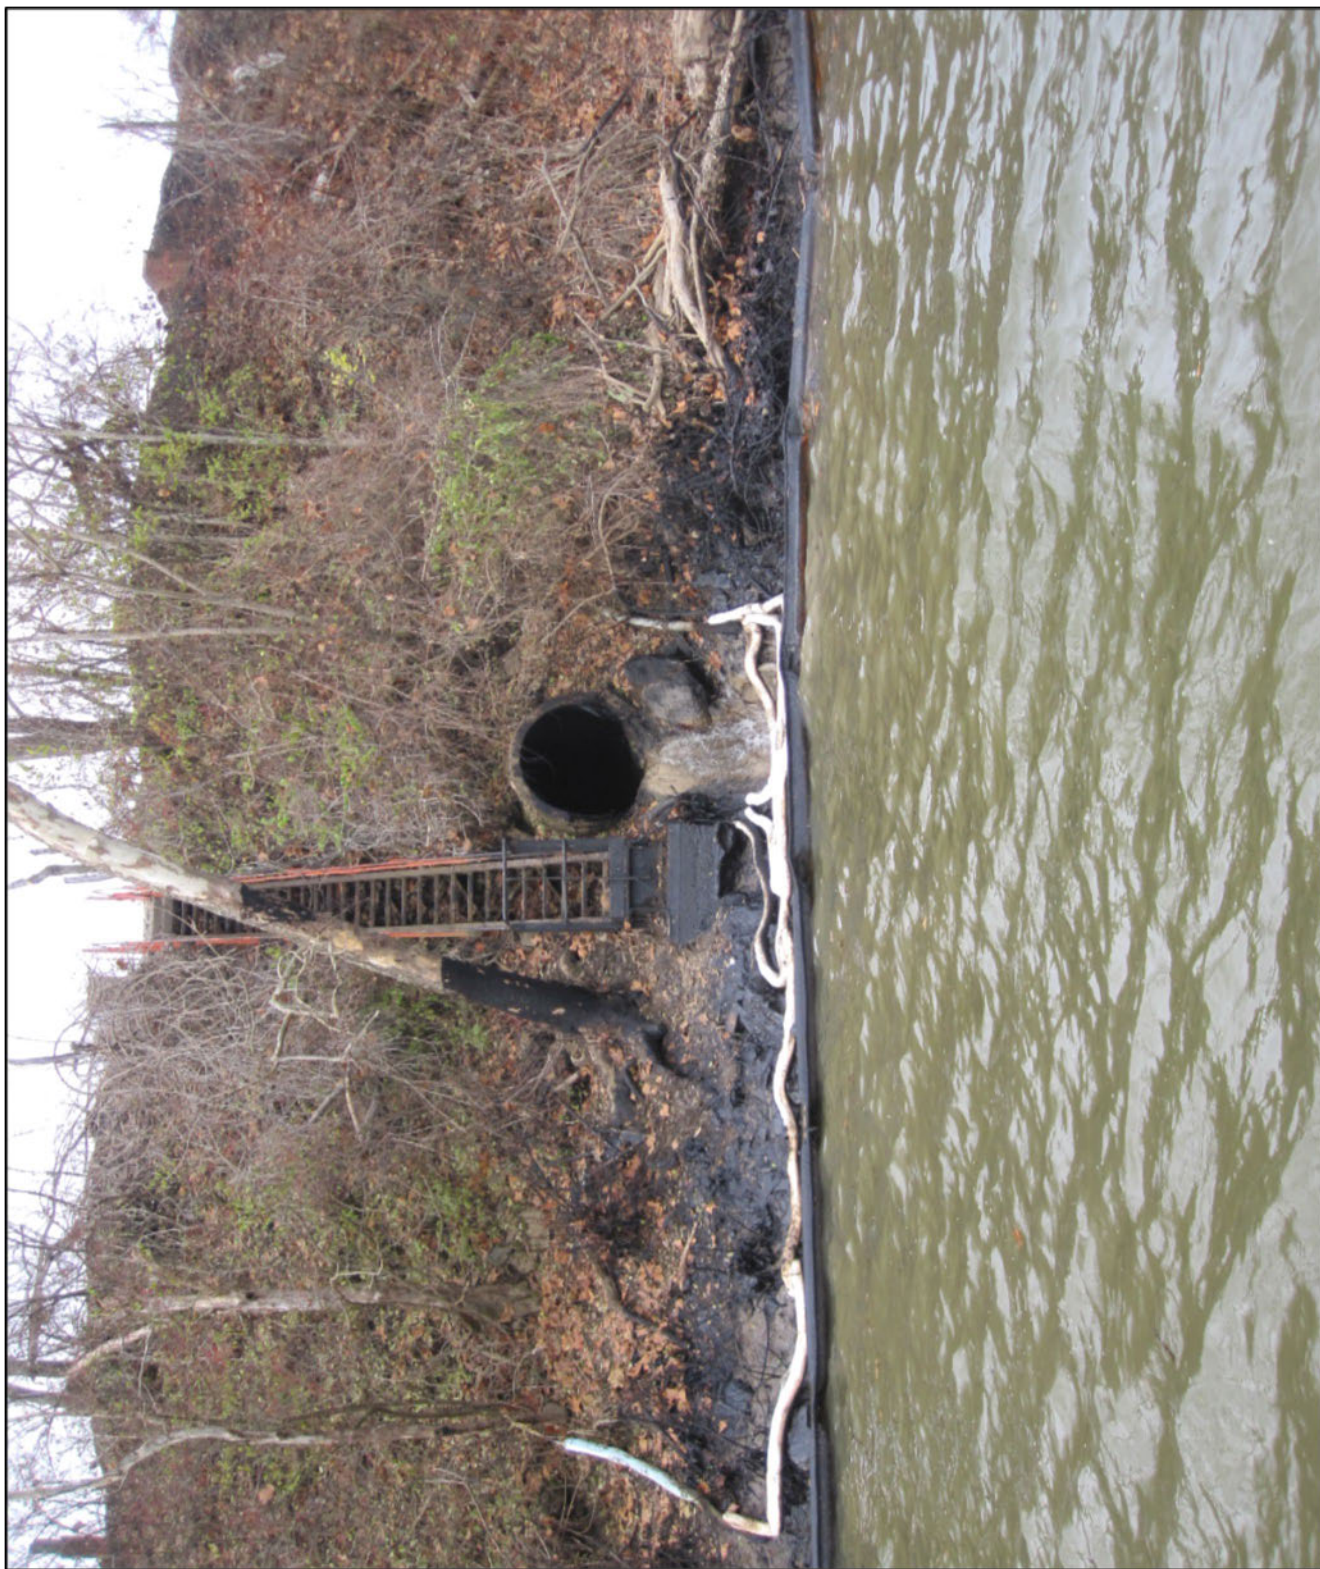
Photolog 183: Condition of outfall and riverbank after Phase 1 response actions - replacing storm water piping to mitigate oil discharge. 12/6/2018. (START photo IMG_1206.jpg)
